Major Masonry Repair on Perimeter Walls and Ramps

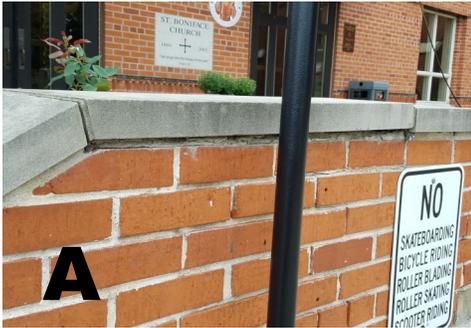
The problem is a result of water damage, or water is being allowed into these walls by failing cap stone joints. In **photo A** you can see how the problem first presents itself as a small flake of surface brick separating from the main body of the brick. Just as water will expand in a bottle when frozen and rupture the can so will water in a brick expand and crack the brick.

After consultation and proposals from three masonry companies, the STB Building and Grounds Committee, recommended contracting Precision Industrial Ltd of Edwardsville to begin work immediately in order to prevent more damage before winter weather approaches. The cost of the project is \$85,000.

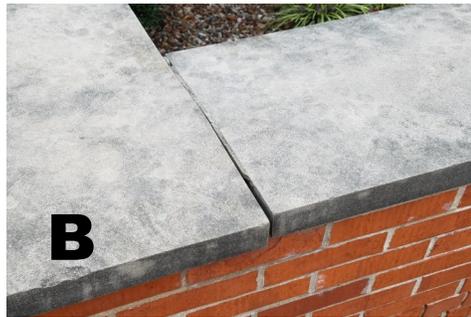
In **photo B** the problem that allowed this water problem is evident. One of the delays in realizing the problem was that the splits between the cap stones was small and unnoticeable when passing by but none the less, large enough to allow water in.

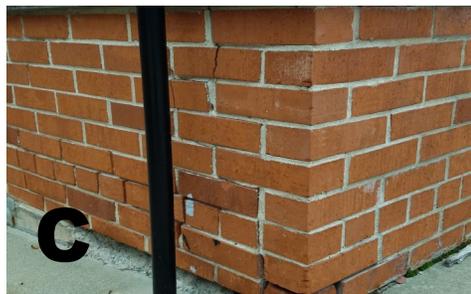
As this water found its way behind the bricks its next natural progression was to escape from the wall. Water will always seek the path of least resistance and in **photo C** it can easily be seen how the mortar has been destroyed both wrecking the wall and allowing more water in only making the problem worse.

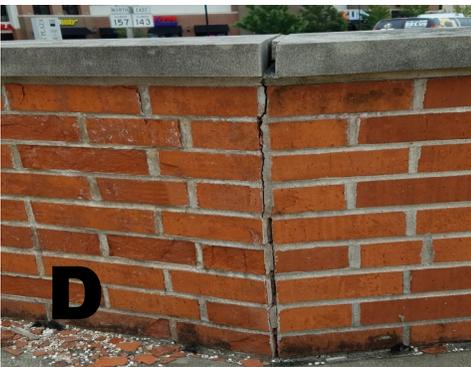
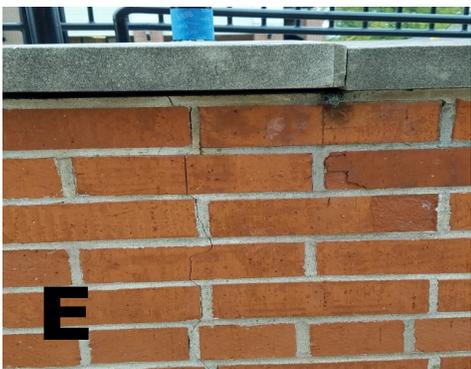
In time the wall will begin to lose its stability if the water is not stopped as can be seen in **photos D and E** resulting in damage that goes far and beyond tuck pointing and brick replacement. We are now at that point in many areas of the perimeter walls and ramps forced to make the investment to repair, restore and protect the Church from further damage to ensure that it remains the proud landmark it has always been here in Edwardsville.
